## **PERFORMANCE OF PRECAST CONCRETE FLOOR SYSTEMS DURING THE 2010/2011 CANTERBURY EARTHQUAKES**

R S HENRY, J M INGHAM

Department of Civil and Environmental Engineering, University of Auckland

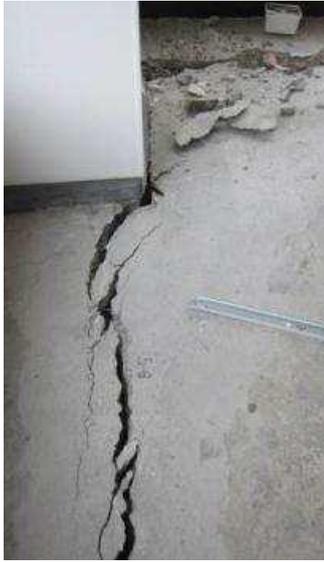
As reported previously by Kam et al. (2010; 2011), cracks were observed in floor diaphragms where beam hinging and elongation had occurred in multi-storey buildings. As shown in Figure 1, cracks were observed in the cast-in-place topping of several floors, both at the joint between the beam and the precast unit, and at the joints between precast units. In many cases wide cracks led to the fracture of non-ductile mesh used in the topping concrete. The lack of robustness of non-ductile mesh has been recognised for several years, and current regulations required that ductile seismic grade reinforcing steel be used in floor diaphragms. In the building shown in Figure 1c and d, cracks were observed in the topping at almost all of the joints between the precast flat slab units. Although this loss of continuity in the topping does not threaten the vertical stability of the floor diaphragm, an increase in the flexibility and noticeable sagging of the floor diaphragm was observed. As noted in the SESOC preliminary observations report (2011b) and by Kam et al. (2011), it is recommended that a more robust and unified design method is required for floor diaphragms, and this design method should be developed with equal consideration to all types of floor system.

(a) Cracking due to beam elongation  
(Credit: Kam et al. 2011)

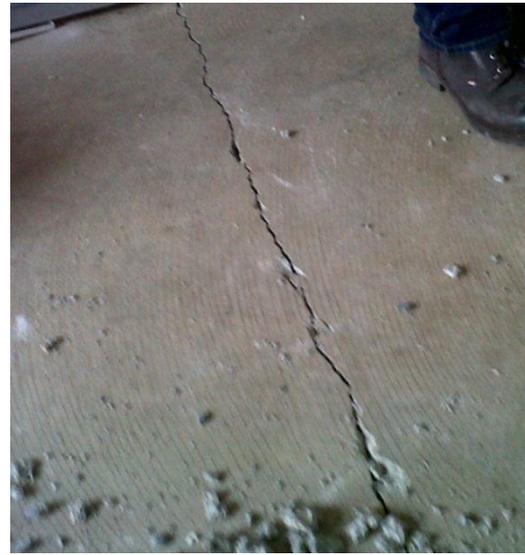
(b) Cracking at joints between precast units  
(Credit: John Marshall)

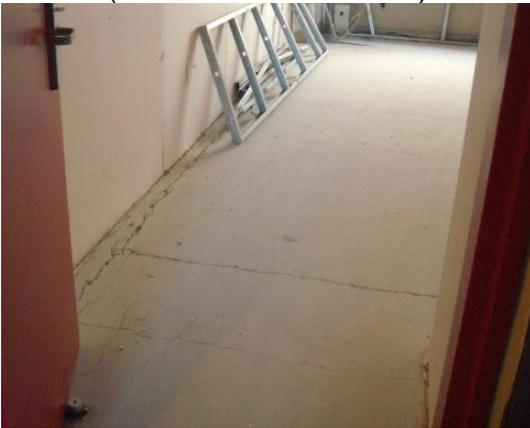
(c) Cracking at joints between precast units  
(Credit: John Marshall)

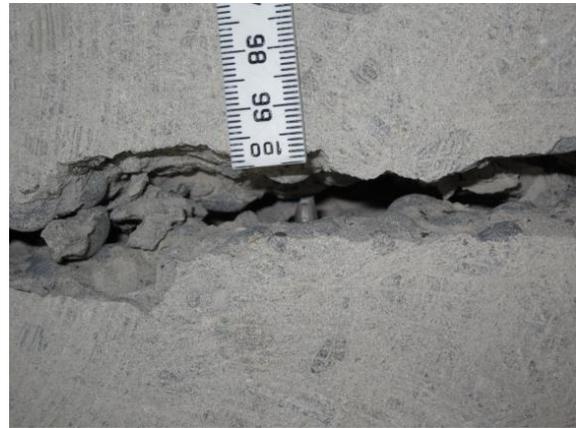
(d) Mesh fracture in topping  
(Credit: Rod Fulford)

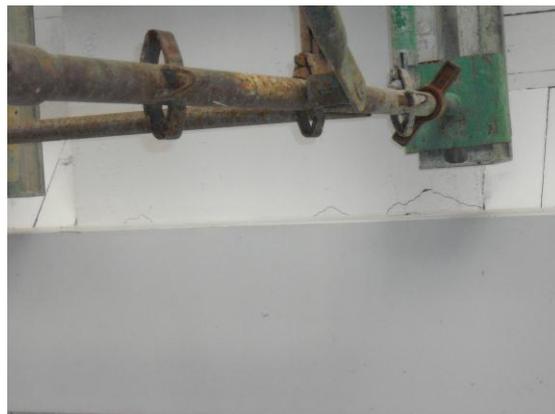
A single storey carpark structure with spaced hollow-core floor units, shown in Figure 2, suffered minor damage during the 4 Sept 2010 earthquake and was severely damaged during the 22 Feb 2011 earthquake. As shown in Figure 2b, cracks were observed in two hollow-core units oriented parallel to the beam support following the 4 Sept 2010 earthquake. On-site load tests confirmed that these cracks did not compromise the vertical load carrying capacity of the floor. During the 22 Feb 2011 earthquake the connection between the floor diaphragm and the shear walls failed, causing the ramp to act as a strut to resist the lateral forces generated in the structure. As a consequence of this unintended strut action, the hollow-core units in the ramp structure were badly damaged, as shown in Figure 2d. However the ramp structure would have suffered damage irrespective of the type of floor construction due to inadequate design and detailing. Because this structure was only single storey and responded with a column-sway mechanism during the earthquakes, beam elongation and/or large rotations between the hollow-core and support beam did not

(b) Cracking at unit end following 4 Sept 2010

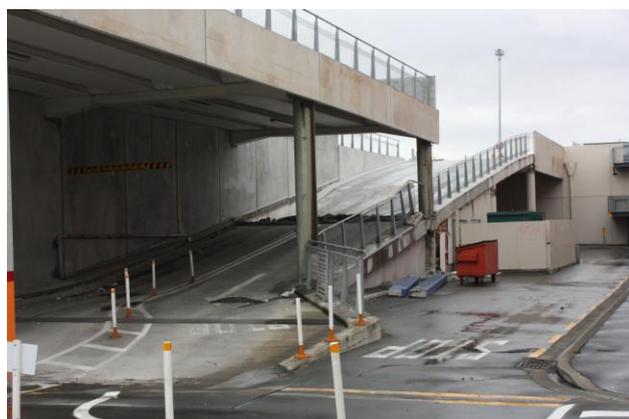
(c) Damaged ramp structure following 22 Feb 2011

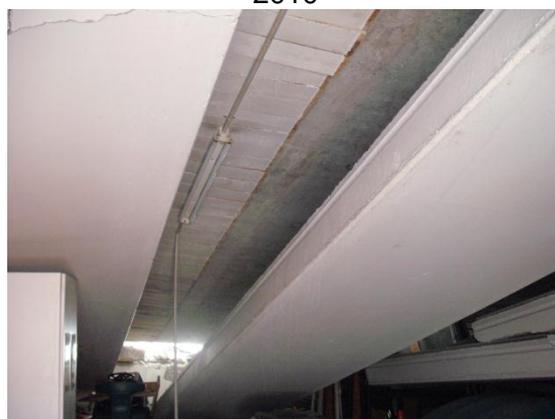
(d) Damaged units in the ramp structure following 22 Feb 2011

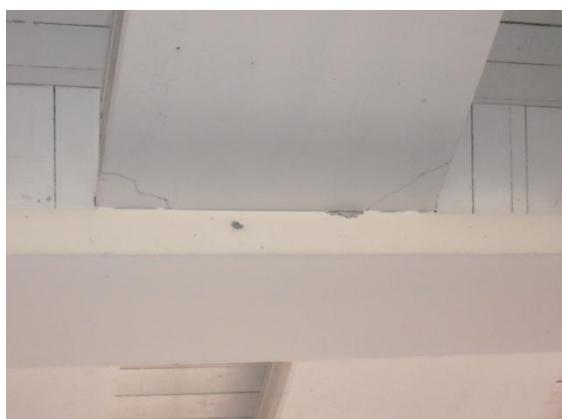
In spaced hollow-core floors, cracking was noted at the corners of the units at the support, as shown in Figure 3. These corner cracks occurred in several different buildings with spaced hollow-core units and are possibly induced by torsion rotation of the hollow-core unit. The corner cracks did not appear in hollow-core units that were placed directly adjacent to one another.

(a) Cracks in the unit corners

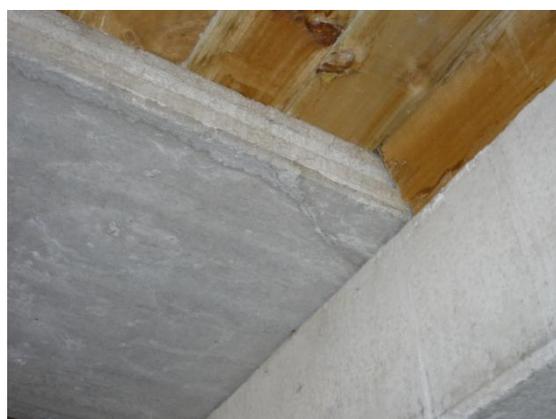
(b) Cracks in corner and parallel to unit edge

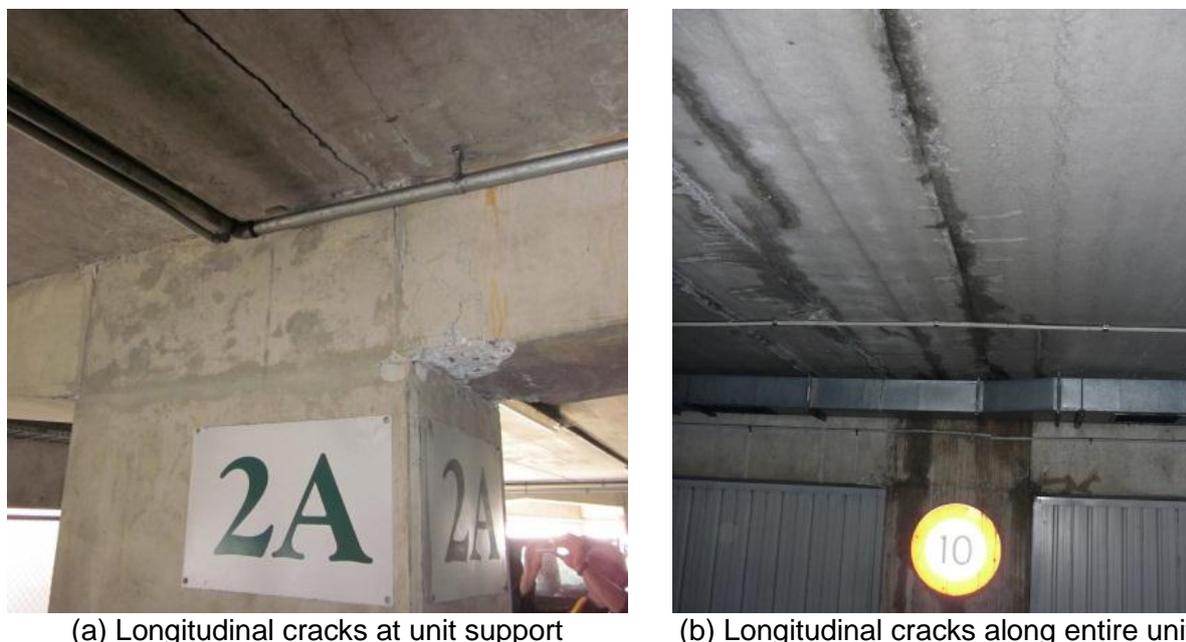
Another observed damage pattern was longitudinal splitting cracks in hollow-core units, as shown in Figure 4. These longitudinal cracks were observed in a couple of buildings where the hollow-core units spanned perpendicular to moment resisting frames and flexural cracks at the ends of the beams elongated the floor diagram. This behaviour was only observed in older buildings where no bearing strip was placed at the hollow-core support, and so the hollow-core units tended to crack directly adjacent to the location of the beam flexural cracks. It is expected that the effect of this displacement incompatibility would be minimised if current recommended hollow-core seating details were used.

Figure 4. Longitudinal cracks in hollow-core units (Credit: Rod Fulford and John Marshall)

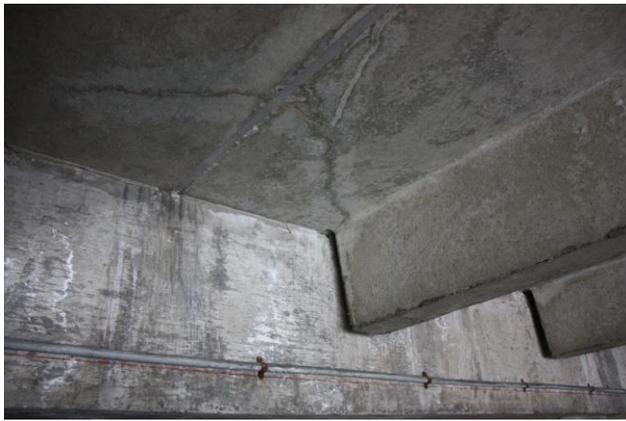
Double-tee floor units in Christchurch incorporated several support details, including being web-supported, having dapped end supports, and being flange-supported. Flange-supported units tend to be preferred by designers due to the minimised inter-storey height and improved geometry for shrinkage and thermal effects when compared to web supported units. The majority of the flange-supported double-tees in Christchurch would have been constructed using the loop-bar hanger detail. In general, no serious failure of the double-tee units or supports were noted. Figure 5 shows existing cracks in the flange-supported double-tees that propagate from the support parallel to the web and then at 45 degrees across the flange. This type of cracking is common in flange-supported double-tees and does not compromise the vertical load carrying capacity of the floor.

(a) Cracks at 45 degrees in the flange

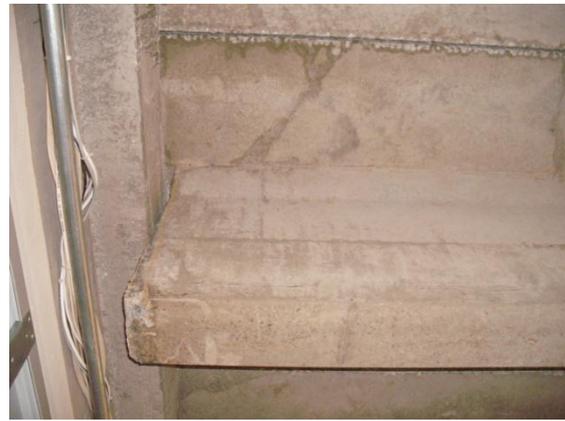
(b) Cracks parallel to the web and at 45 degrees across the flange

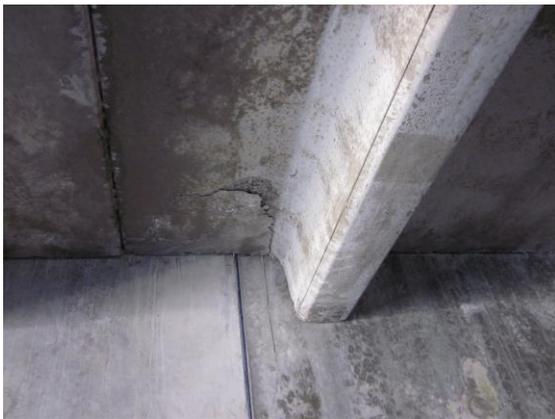
The earthquakes appear to have exacerbated existing cracks in flange-supported double-tees. As shown in Figure 6a, a possible existing crack has widened and some spalling has occurred, in this case possibly due to vertical movement at the joint between the two wall panels that the double-tee is seated on. A retrofit strategy to prevent loss-of-support of flange-supported double-tees is shown in Figure 6b.

(a) Cracking in flange

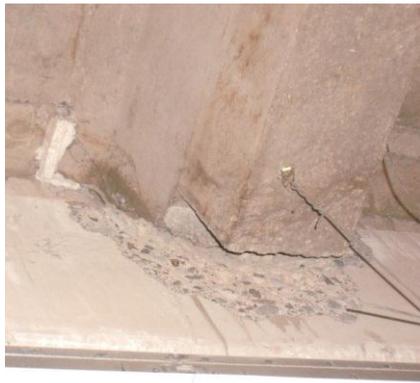
Minor damage was observed to older double-tee units with dapped end supports. As shown in Figure 7, unprotected dapped end supports exhibited some spalling of the beam edge and vertical cracking in the double-tee web. In contrast, armoured dapped end supports with steel angles on the beam edge and on the underside of the double-tee web performed well with no damage observed, as shown in Figure 7c. The SESOC recommendations that web supported and dapped end supported double-tee units should be armoured with steel angles in order to avoid minor damage appears to be logical (Structural Engineering Society of New Zealand (SESOC) 2011a).

(a) Spalling at unprotected support

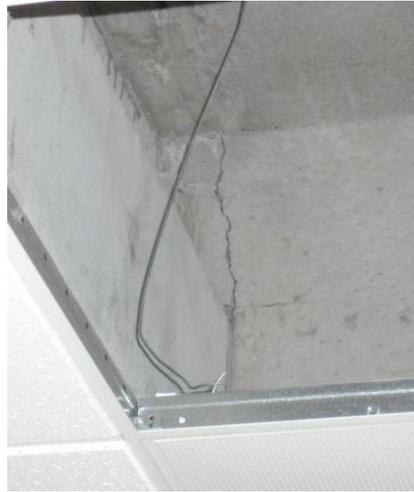
(b) Cracking at unprotected support

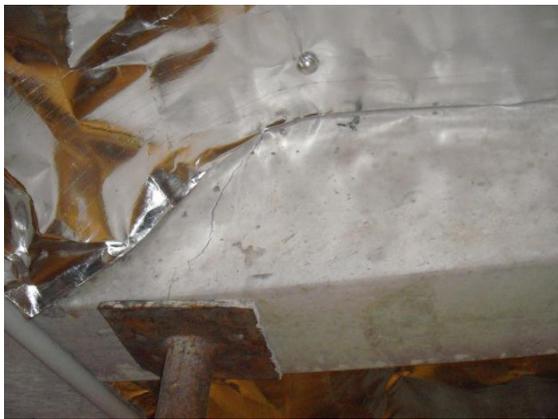
In general rib-and-timber infill floors performed well during the earthquakes. The ability of the flexible infill strips to accommodate movement and distribute cracks reduced the potential for damage to rib-and-timber floors. However, one common damage pattern was the formation of flexural cracks at the ends of the prestressed ribs, as shown in Figure 8. The rib support conditions typically provide a partially fixed restraint and the ribs have little flexural capacity due to the transfer length of the prestressing strands. The SESOC recommendation that stirrups be placed in the ribs over the transfer length is again logical in order to improve the robustness of the support (Structural Engineering Society of New Zealand (SESOC) 2011a). However, it should be noted that the use of stirrups at the ends of the prestressed ribs is already consistent with current practice (Cook 2012).

(a) Side view of cracked rib

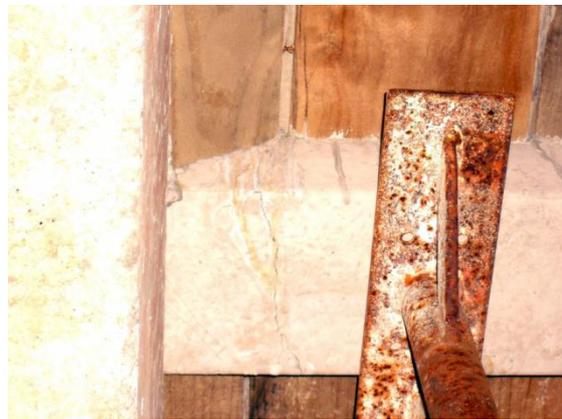
(b) Underside of cracked rib

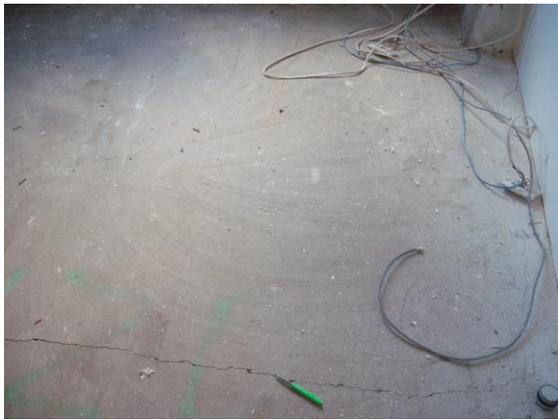
Floors with flat-slab units also performed well during the earthquakes, with only minor damage observed. As explained earlier, cracks in the cast-in-place topping were observed at the joints between flat slab units, as shown in Figure 9a. Additionally, in the same building cracks were observed in the corners of the precast flat slab units, in particular close to the corner of the building, as shown in Figure 9b.

(a) Cracking in topping between precast units

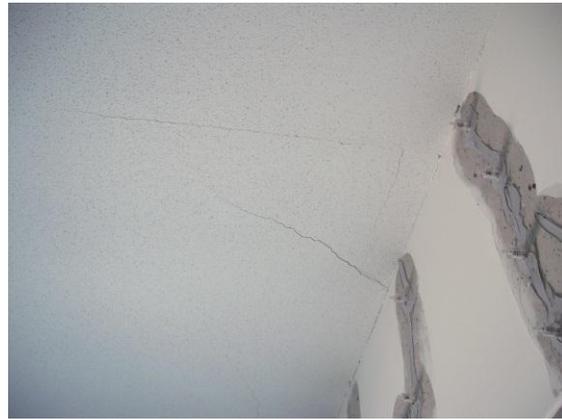
(b) Cracking in the corner of precast unit
