## **PERFORMANCE OF PRECAST CONCRETE FLOOR SYSTEMS DURING THE 2010/2011 CANTERBURY EARTHQUAKES**

R S HENRY, J M INGHAM

Department of Civil and Environmental Engineering, University of Auckland

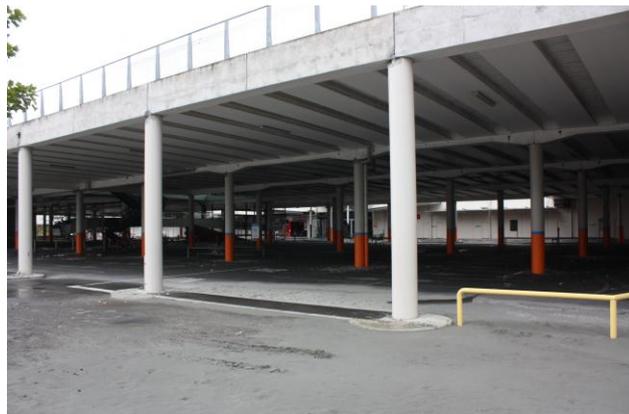
A single storey carpark structure with spaced hollow-core floor units, shown in Figure 2, suffered minor damage during the 4 Sept 2010 earthquake and was severely damaged during the 22 Feb 2011 earthquake. As shown in Figure 2b, cracks were observed in two hollow-core units oriented parallel to the beam support following the 4 Sept 2010 earthquake. On-site load tests confirmed that these cracks did not compromise the vertical load carrying capacity of the floor. During the 22 Feb 2011 earthquake the connection between the floor diaphragm and the shear walls failed, causing the ramp to act as a strut to resist the lateral forces generated in the structure. As a consequence of this unintended strut action, the hollow-core units in the ramp structure were badly damaged, as shown in Figure 2d. However the ramp structure would have suffered damage irrespective of the type of floor construction due to inadequate design and detailing. Because this structure was only single storey and responded with a column-sway mechanism during the earthquakes, beam elongation and/or large rotations between the hollow-core and support beam did not

(a) Overview of the structure

Figure 2. Single storey parking structure with hollow-core units (Credit: Rick Henry and John Marshall)

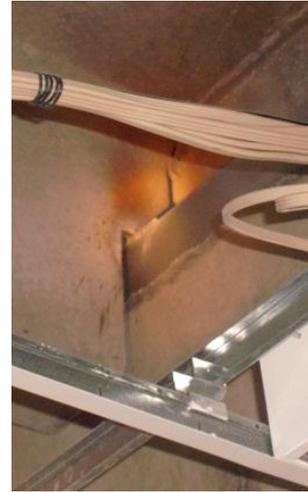
Minor damage was observed to older double-tee units with dapped end supports. As shown in Figure 7, unprotected dapped end supports exhibited some spalling of the beam edge and vertical cracking in the double-tee web. In contrast, armoured dapped end supports with steel angles on the beam edge and on the underside of the double-tee web performed well with no damage observed, as shown in Figure 7c. The SESOC recommendations that web supported and dapped end supported double-tee units should be armoured with steel angles in order to avoid minor damage appears to be logical (Structural Engineering Society of New Zealand (SESOC) 2011a).

(c) Undamaged protected support

Figure 7. Dapped end support of double-tee units (Credit: John Marshall)
